TCS No. 2025/65
IE No. 59/65
25 February 1965
Copy No. 1

SUBJECT : Ryazan Petroleum Refinery, USSR

1. This memorandum is forwarded in answer to the above mentioned requirement which requested an analysis and a comparative study of the petroleum refinery located near Ryazan, USSR.

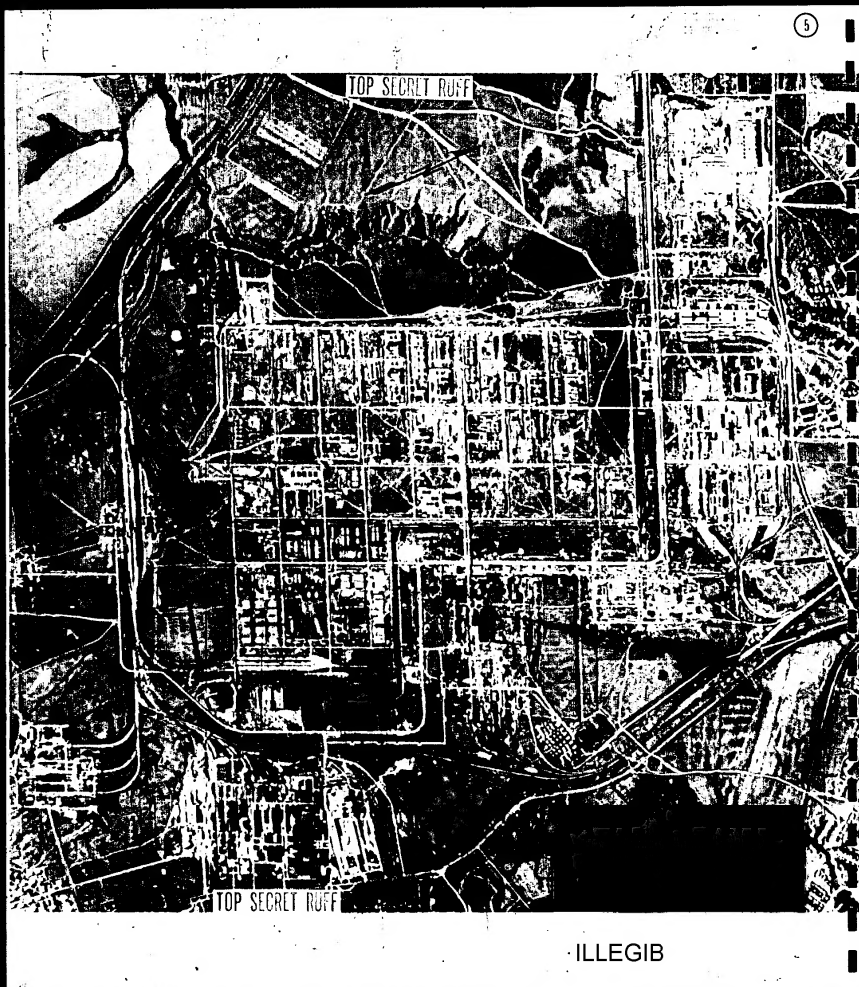
[REDACTED] respectively (See Figures 3-5). The attached graphics have been arranged in a chronological order. Figure 5 contains all of the pertinent data, including an overlay with annotations. Detail concerning the changes that have occurred are given in chronological order in the following paragraphs.

3. The overlay accompanying Figure 5 outlines the refinery area and the various sections within the refinery. The following legend is keyed to the annotated overlay:

- (1) Flare tower
- (2) Fractionation units - with associated facilities and probable desalting units
- (3) Cracking units
- (4) Probable alkylation unit with associated facilities
- (5) Probable lubricating refining area
- (6) Administration area
- (7) Probable distillation units with associated facilities
- (8) Probable vapor recovery units
- (9) Cooling towers and ponds
- (10) Machine shops and warehouses
- (11) Unidentified processing unit - containing a small furnace and possibly four distillation type towers, a pipeline from the main refining area serves this unit and the possible petrochemical plant (Annotation 16)
- (12) Tank farm - containing cylindrical storage tanks and square semiburied tanks.
- (13) Heat and power plant
- (14) Railcar loading and unloading facilities
- (15) Water treating ponds
- (16) Possible petrochemical plant
- (17) Suspect synthetic fiber plant

4. The refinery appeared in [REDACTED] with several of the refinery units completed and in operation (See Figure 3). A large number of the other units were in early stages of construction. Construction on the possible petrochemical plant had not begun. The photography of [REDACTED] (See Figure 5) shows these refining units as having been completed, however there is still sufficient space for many more units. New ground scars and structures have appeared in the vicinity of the flare tower.
